# HEAP LEACH PAD DESIGN AND CONSTRUCTION PRACTICES IN THE 21<sup>ST</sup> CENTURY

By Allan J. Breitenbach, P.E., SME Member  
Vector Colorado LLC

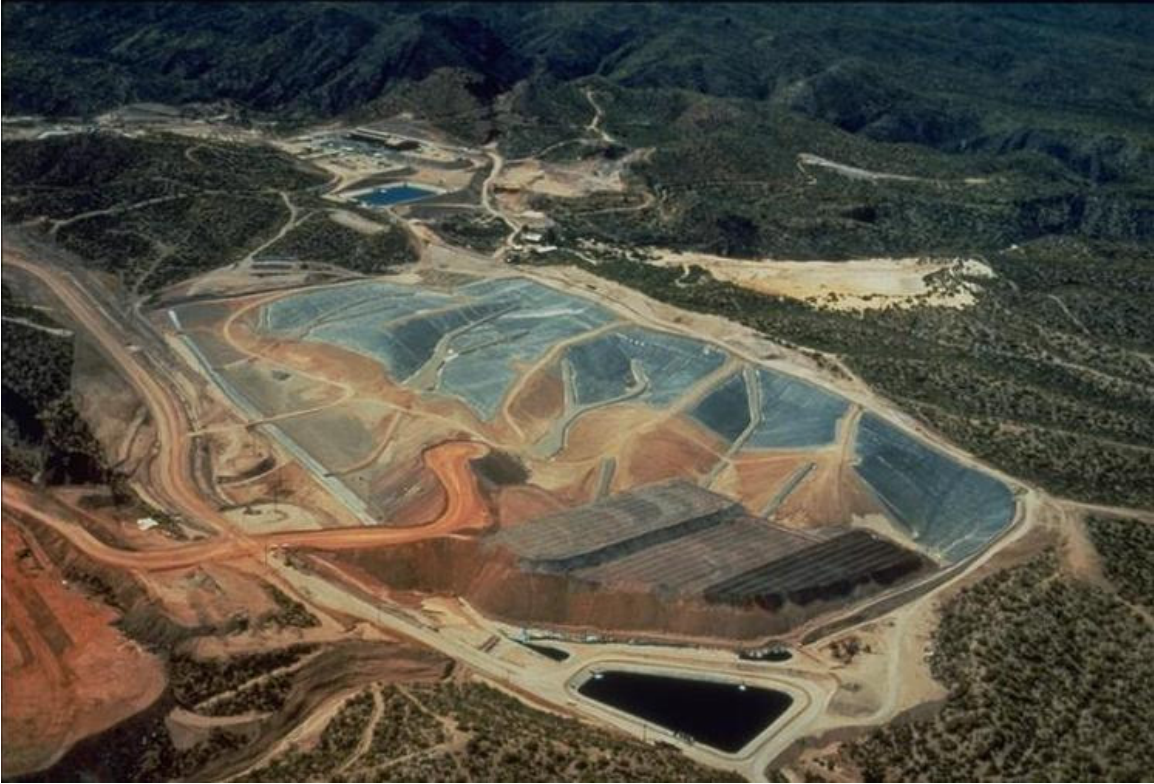
**PHOTO 1 – GEOMEMBRANE LINED COPPER HEAP LEACH OPERATION IN ARIZONA**

The mining industry has been using geomembrane liners for fill structures and ponds for more than 30 years, starting with brine solar evaporation ponds in Utah in the early 1970's. Geomembrane liners for heap leach operations have been around for more than 25 years, starting with gold and silver heap leach pads in Western Montana and Southern California in 1979. Geomembrane lined copper heap leach pads started in Mexico and Arizona as early as 1983, however the copper heap leach dump operations have gradually changed to geomembrane lined foundations and interlift liners within the last 5 to 10 years. An early geomembrane lined copper heap leach operation in Arizona is shown on **Photo 1**.

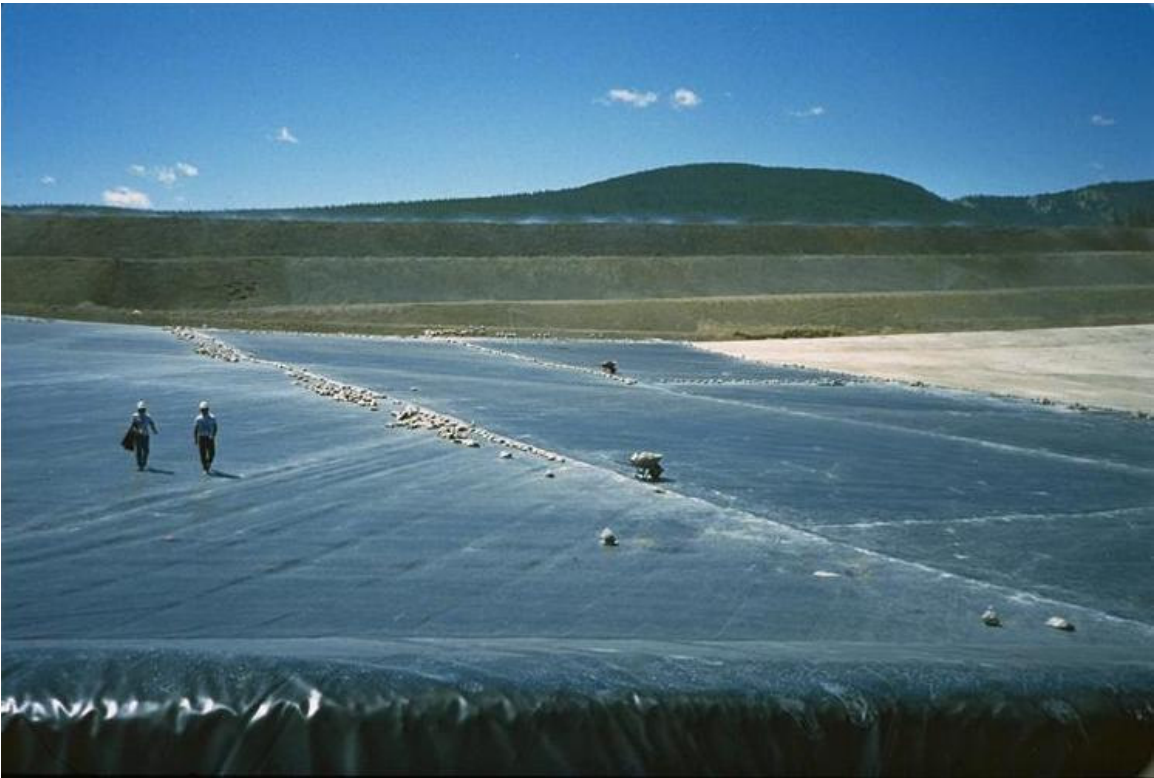
**PHOTO 2 – GEOMEMBRANE LINED GOLD HEAP LEACH OPERATION IN MONTANA**

The construction of heap fills involves the placement of precious or base metal ore materials in controlled individual loose and relatively dry fill lifts stacked at the natural angle-of-repose. The heap ore lifts are typically stacked at 15 to 30 feet (5 to 10 meters) in thickness and leached to typical maximum heights in the range of 100 to 200 feet (30 to 60 meters). The highest heap stacks to date exceed 500 feet (150 meters) above the geomembrane lined pad foundation. A geomembrane lined leach pad with a stacked and leached ore heap in the background is shown on **Photo 2**.

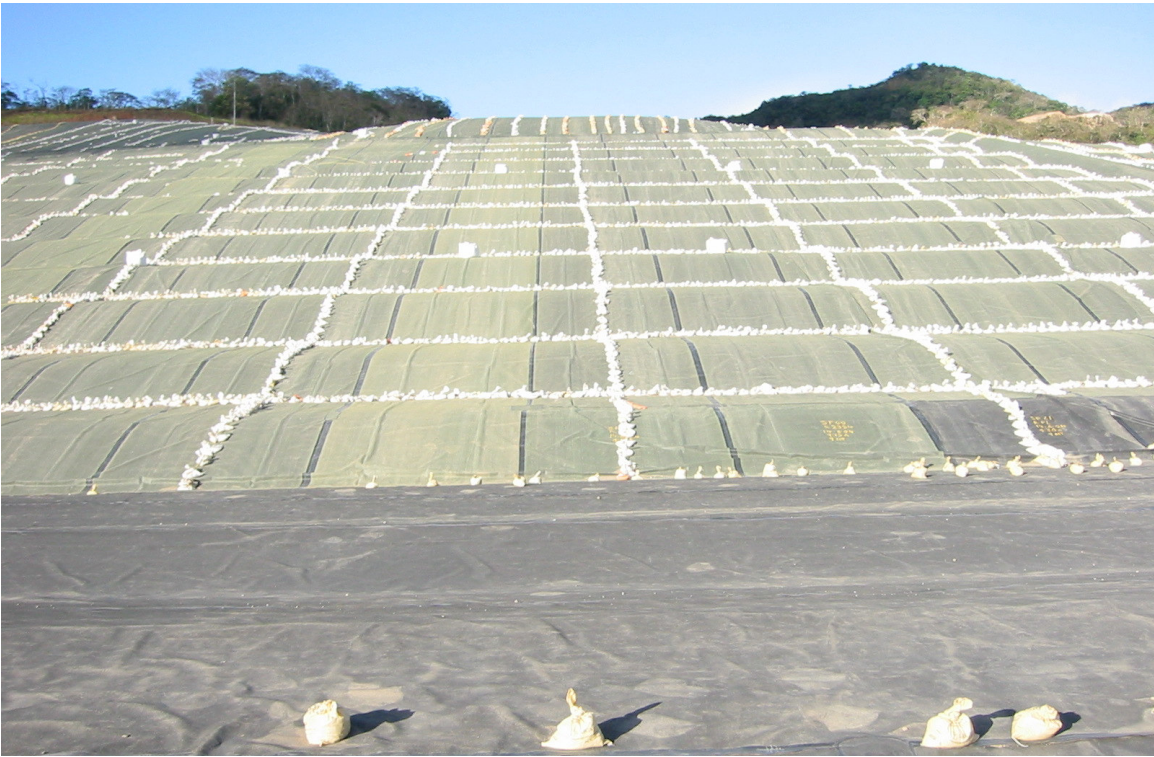
**PHOTO 3 – BENCHED LEACH PAD SURFACE AND TEXTURED LINER FOR STRENGTH**

The planar liner surface strength can be improved for heap stack stability in several ways, including stair-step pad grade construction on steep topography (subgrade slopes steeper than 5 percent) and installing textured versus smooth geomembrane liner in critical pad surface areas. An example of both of these slope strengthening practices is shown on **Photo 3**. The textured liner shown in the photo has a green tint color added by the manufacturer for blending visually with the surrounding terrain.

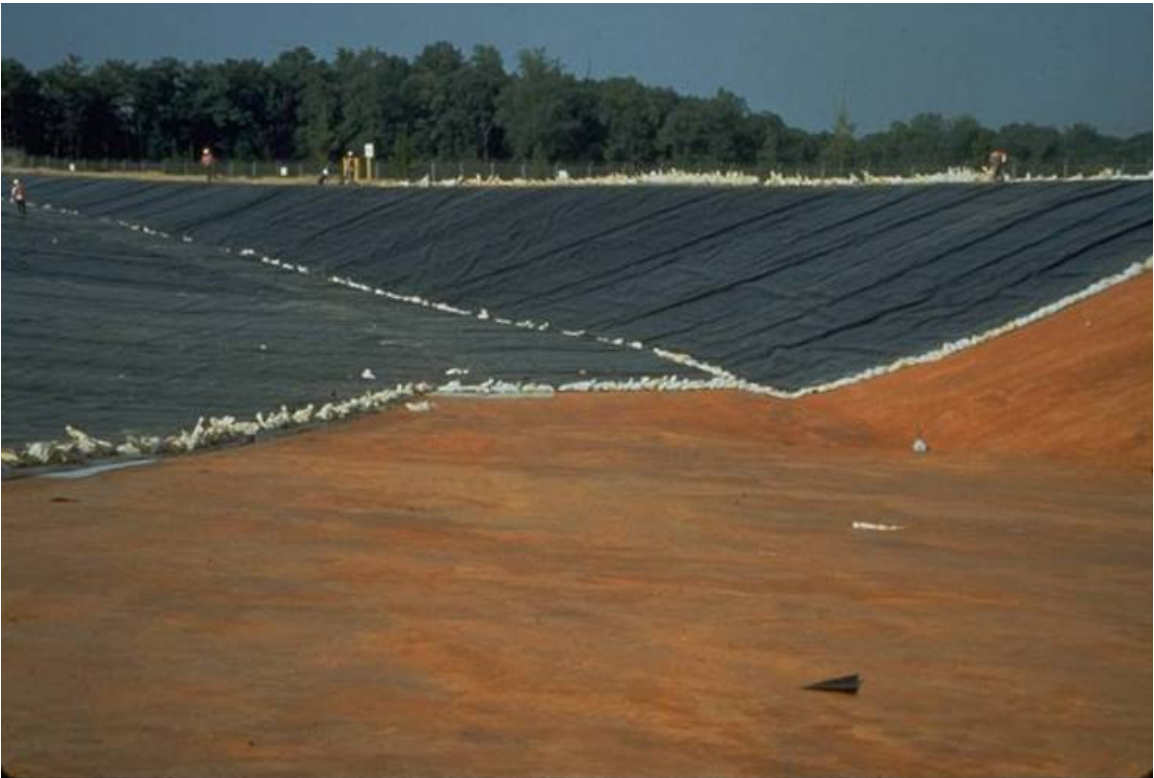
**PHOTO 4 – COMPOSITE CLAYEY SOIL AND GEOMEMBRANE LINER SYSTEM**

The most preferred pad liner system in current heap leach practice is the composite liner with an overlying drain cover fill (Breitenbach 1999). The primary purpose of the composite pad liner design is to prevent the loss of pad and pond process solutions from the lined facilities for both economic and environmental reasons. The composite liner consists of a low permeability subgrade soil in direct contact with the geomembrane liner, as shown on **Photo 4**.

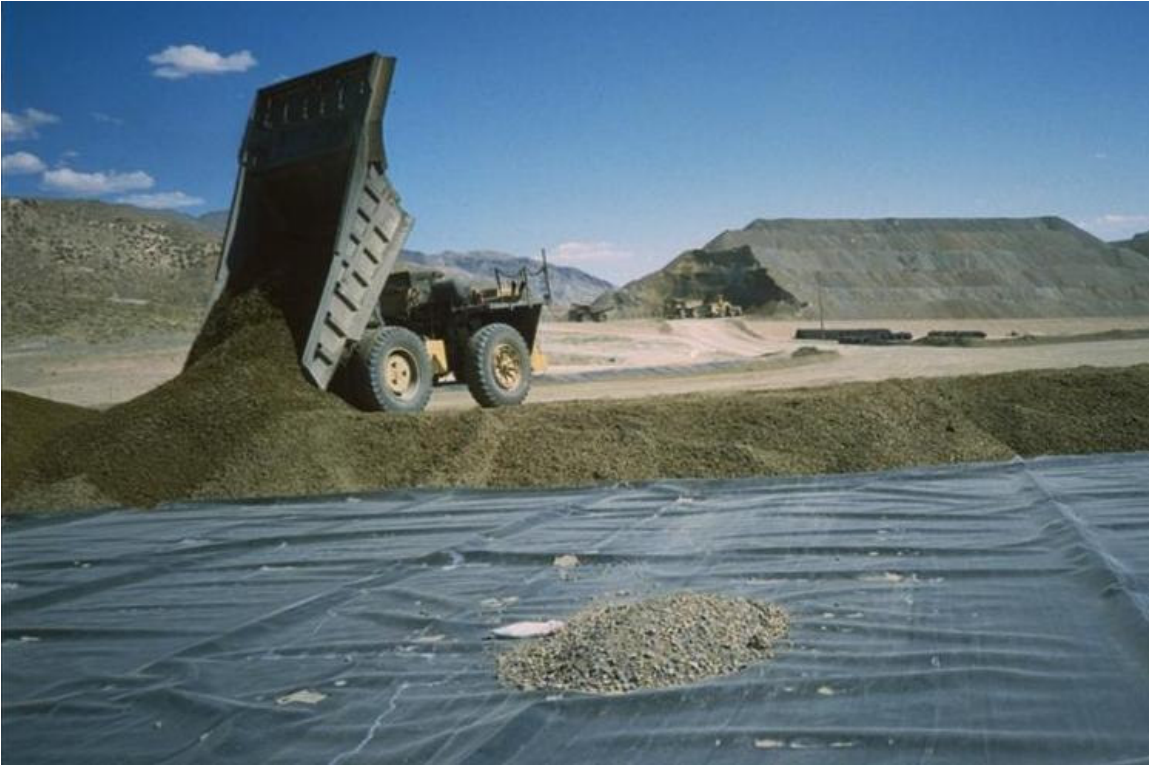
**PHOTO 5 – DRAIN COVER FILL PLACEMENT ON THE PAD LINER SURFACE**

The drain cover fill provides protection to the exposed geomembrane liner and is generally supplemented with drain pipes at controlled spacing. Relatively clean crushed ore materials are often used as the drain cover fill as much as practical. The drain cover fill and drain pipes provide both rapid drainage recovery of the pregnant solutions to the process pond and plant facilities, as well as maintaining low hydraulic heads above the pad liner. A protective drain cover operation is shown on **Photo 5**.

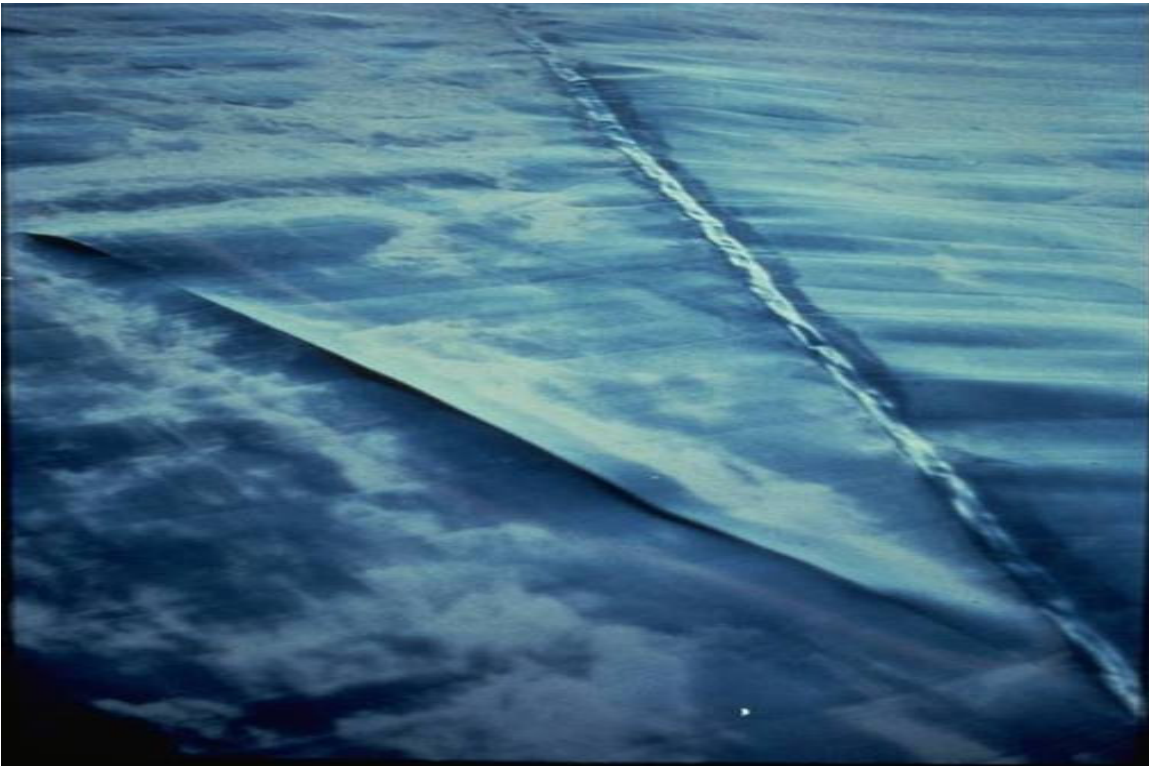
**PHOTO 6 – STRESS CRACK IN HDPE LINER OCCURED ON LARGE EXPOSED PAD AREA**

A secondary purpose for the drain cover fill is liner protection from exposure to the climate and biological or man made conditions. The climate conditions mainly include high winds, temperature fluctuations and exposure to sunlight (UV light). The biological or man made conditions generally include animal hoof or claw damage, equipment or foot traffic, and mine blast fly rock. The geomembrane liners are recommended to be covered on large pad areas as soon as practical with drain fill or ore materials to minimize the potential for stress-cracking, wind movement, folding, sun light degradation and other problems related to exposed liner conditions. Examples of liner exposure problems are shown on **Photos 6 to 9**.

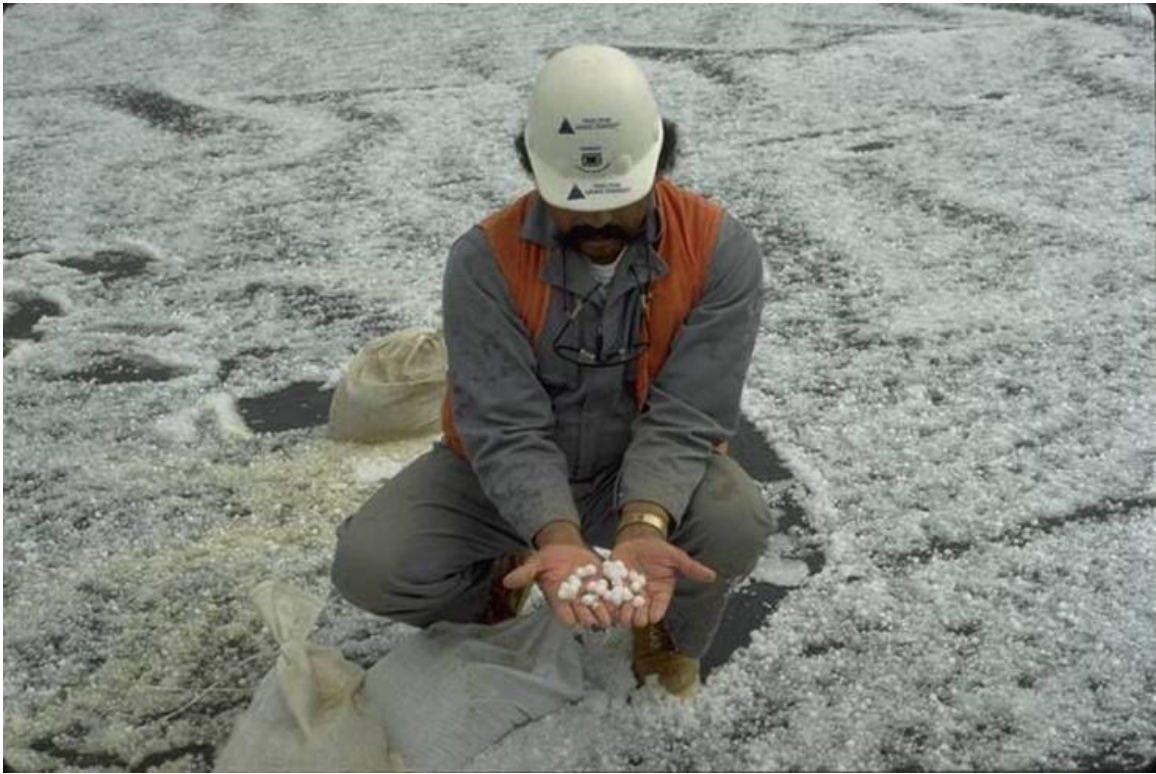
**PHOTO 7 – HAIL AND BLAST FLY ROCK DAMAGE CAN OCCUR ON EXPOSED LINER**

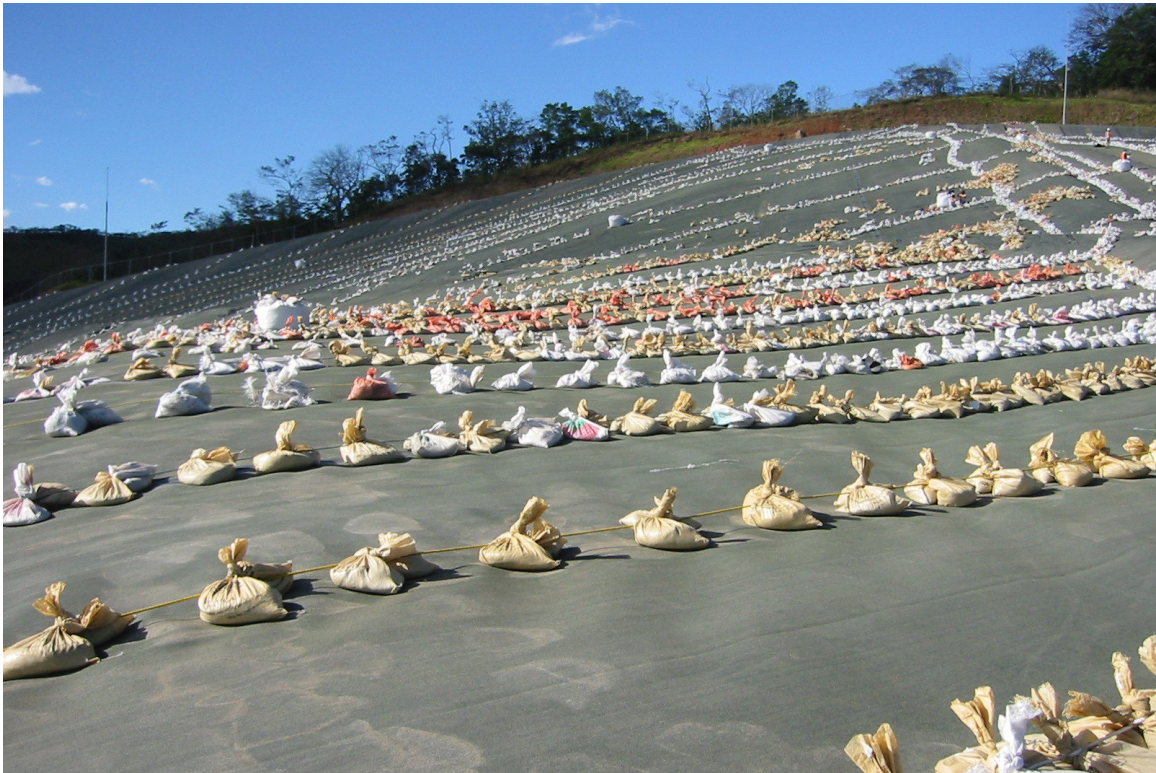
**PHOTO 8 – HIGH WINDS REQUIRE SAND BAGS TO HOLD LINER UNTIL COVERED**

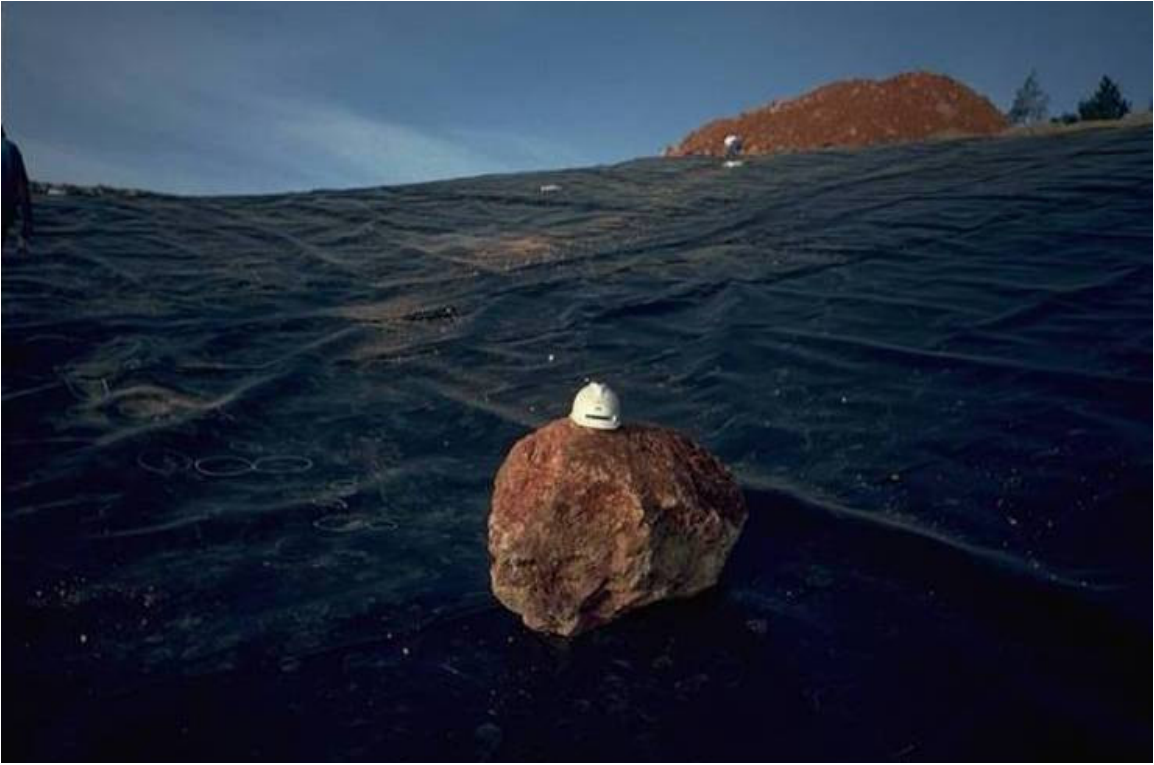
**PHOTO 9 – LARGE BOULDER ROLLED ONTO GEOMEMBRANE LINER SURFACE**

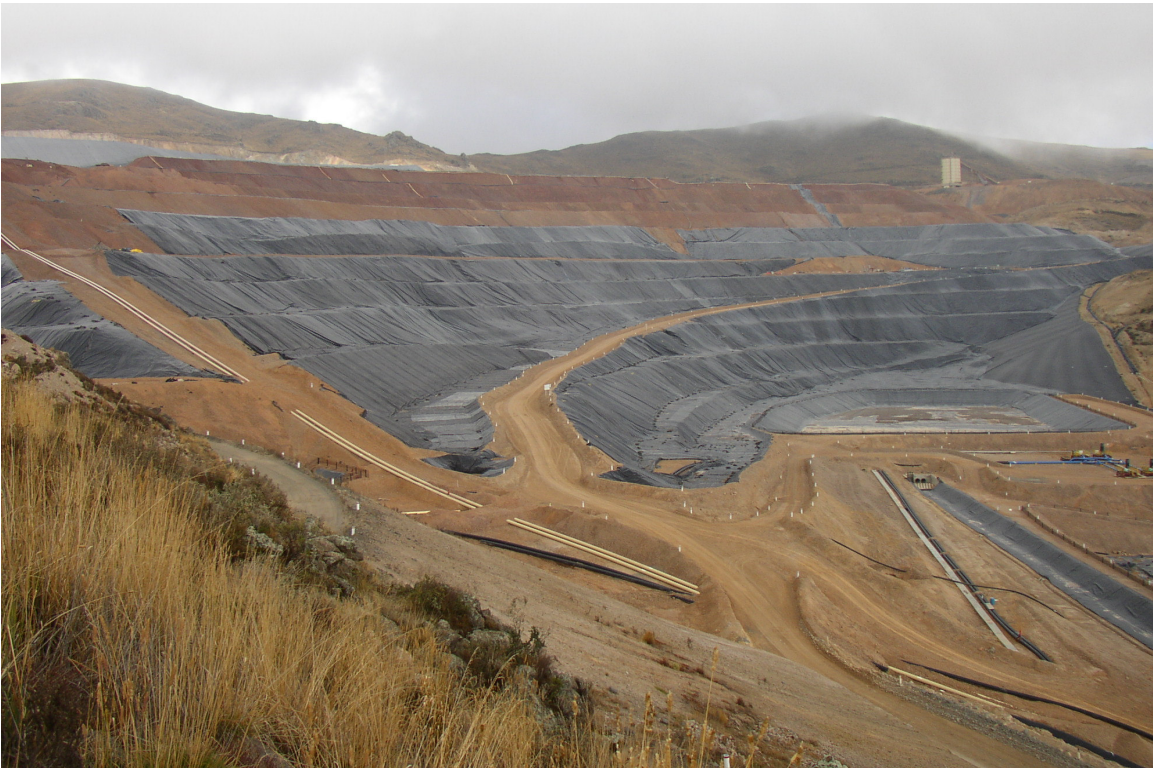
**PHOTO 10 – HEAP SLOPE COVERED BY GEOMEMBRANE LINER RAIN COAT**

A relatively new liner concept used in the Phillipines, Central America and South America since the early to mid 1990's in high rainfall areas is the use of liner rain coats on leached and spent ore slopes to minimize storm runoff flows from the heap stack to the lined collection ponds. This concept allows storm ponds to be sized for startup operation flow volumes, and potentially remain the same size with subsequent lined pad expansions. The liners are temporary for operations and are eventually removed for closure of the facilities. A liner rain coat on the exterior heap stack slopes is shown in **Photo 10**.
